Manhole Inspection Summary

Manhole # S67G__024MH

Inspection ☐ Is Incomplete Rating: **3) Fair**

Insp Date: **6/3/08 10:35 AM**

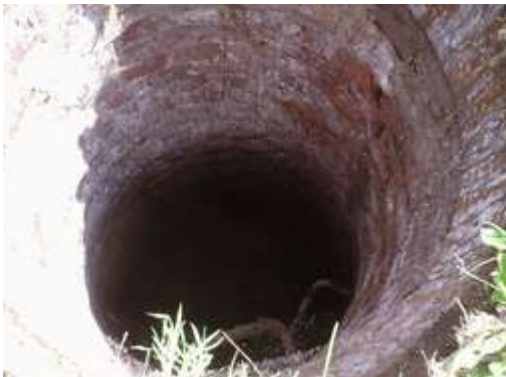
Defect 1

Infiltration: ☐ None ☐ Joint ☐ Cracks ☐ Mortar ☐ Roots ☒ **Wall**

infiltration

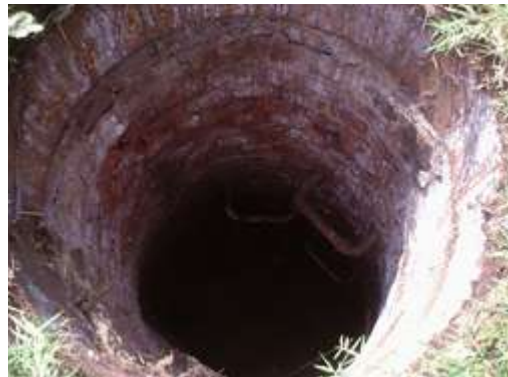
Defect 2

☒ **Leaks**

frame leaks

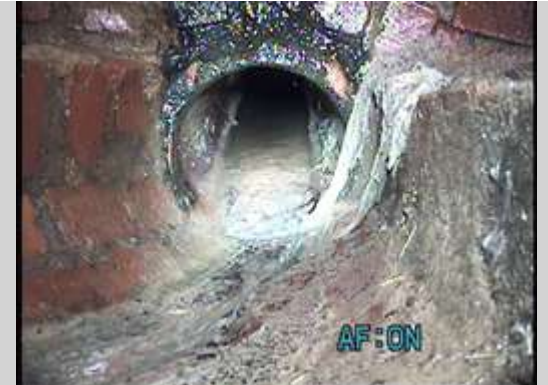
12 O'Clock Outflow

8 in. Circular Gravity Sewer
Pipe Out @ 12 O'Clock

Pipe Height: **8.4** (in.) Rod and Bar (Angled)
Pipe Material: **Clay** ☐ Pipe Lined
Invert Depth: **12.15** (ft.) Flow Characteristics: **Fast**
Deposits: ☒ None ☐ Mud ☐ Sludge ☐ Debris ☐ Grease
Silt Depth: (in.) Deposits Extent:
Infiltration: **None** Pipe Seal Cond: **Sound**

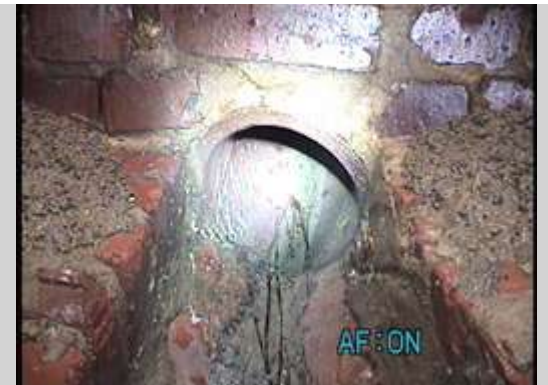
6 O'Clock Inflow

6 in. Circular Gravity Sewer
Pipe In @ 6 O'Clock

Pipe Height: **6** (in.) Rod and Bar (Angled)
Pipe Material: **Clay** ☐ Pipe Lined
Invert Depth: **11.10** (ft.) Flow Characteristics: **Slow**
Deposits: ☒ None ☐ Mud ☐ Sludge ☐ Debris ☐ Grease
Silt Depth: (in.) Deposits Extent:
Infiltration: **None** Pipe Seal Cond: **Sound**

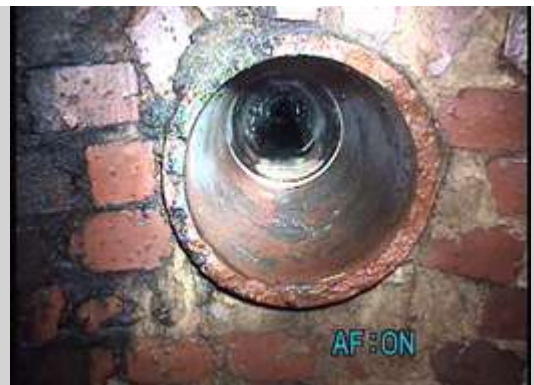
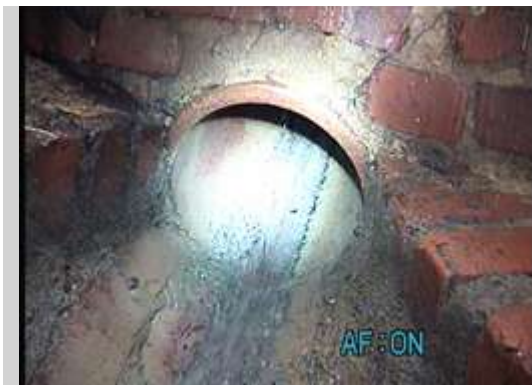
9 O'Clock Inflow

Pipe Height: **8.4** (in.) Rod and Bar (Angled)

Infiltration: **None** Pipe Seal Cond: **Sound**

Drop: **Outside** Rod and Bar

Drop Condition: **Open**
